Volume 2: Appendices

**Immediate Response Action Status  
Report No. 6 and Remedial  
Monitoring Report No. 9**

50 Tufts Street, Somerville, Massachusetts

November 10, 2008  
Project No. 04516-3

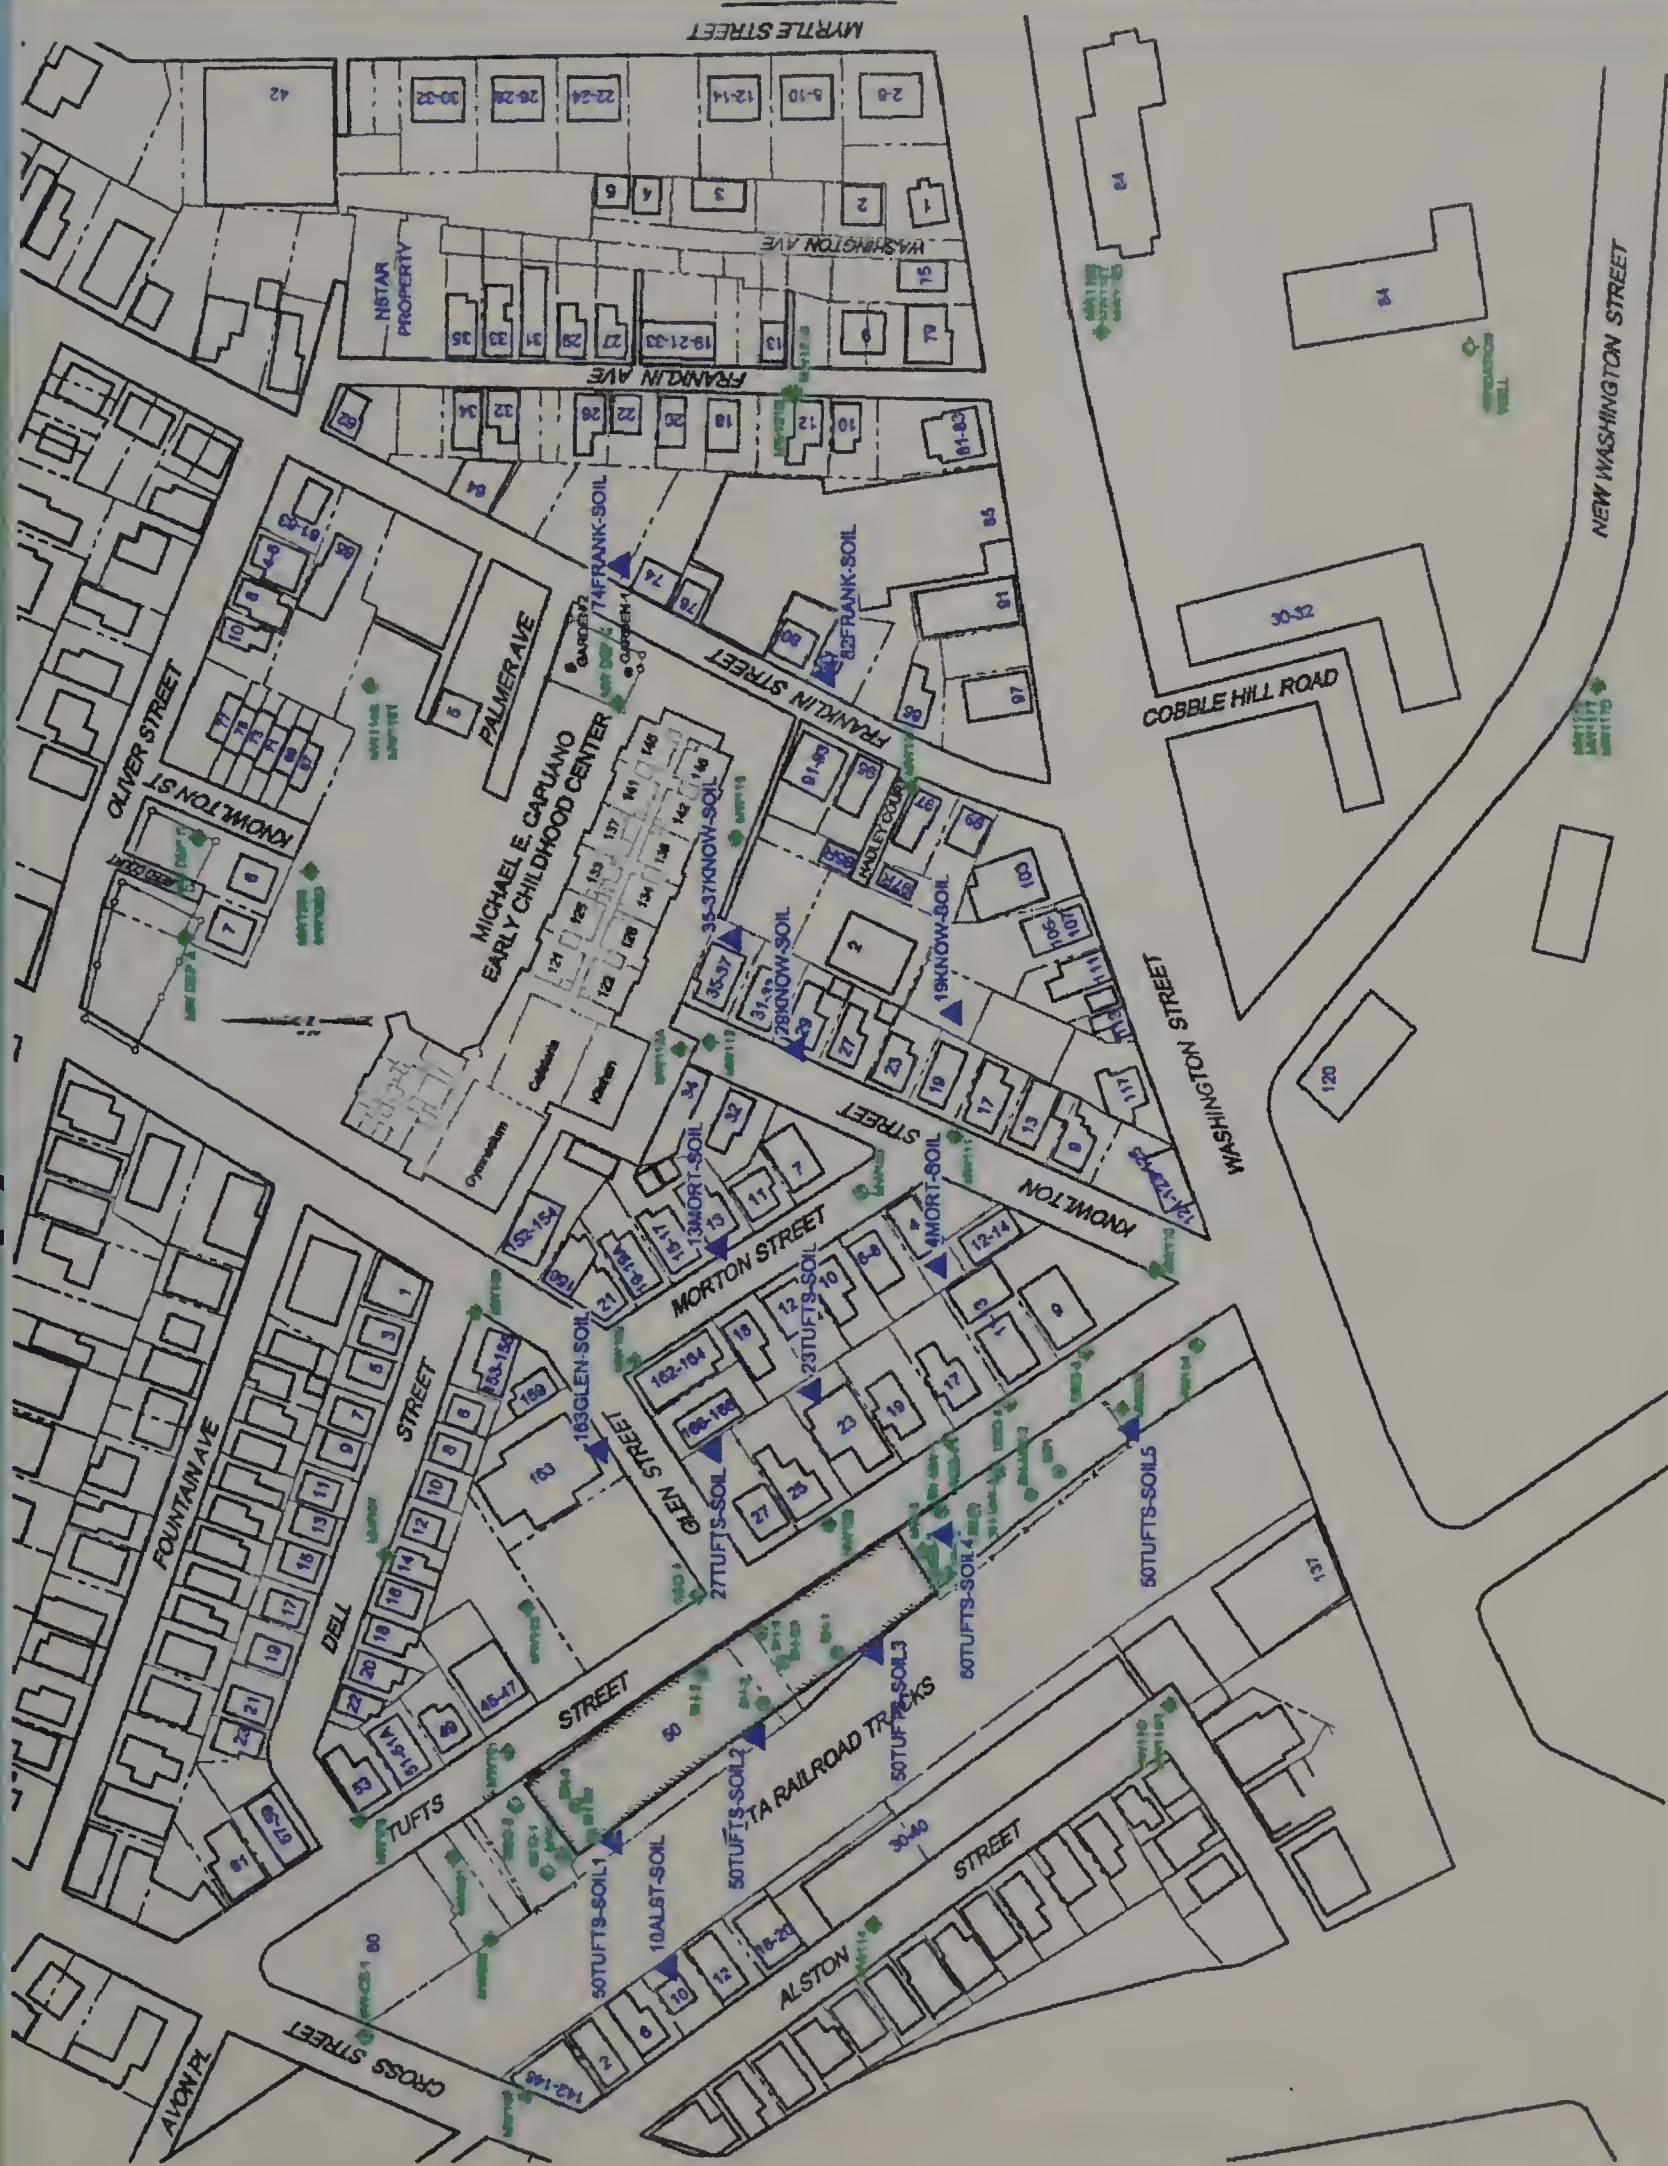
# Monitoring Locations

- Collected and analyzed 97 soil samples
- Conducted 7 rounds of groundwater sampling
- Collected and analyzed 138 groundwater samples
- Collected and analyzed 77 subsurface soil vapor samples
- Conducted 26 measurements of groundwater surface to map groundwater flow.

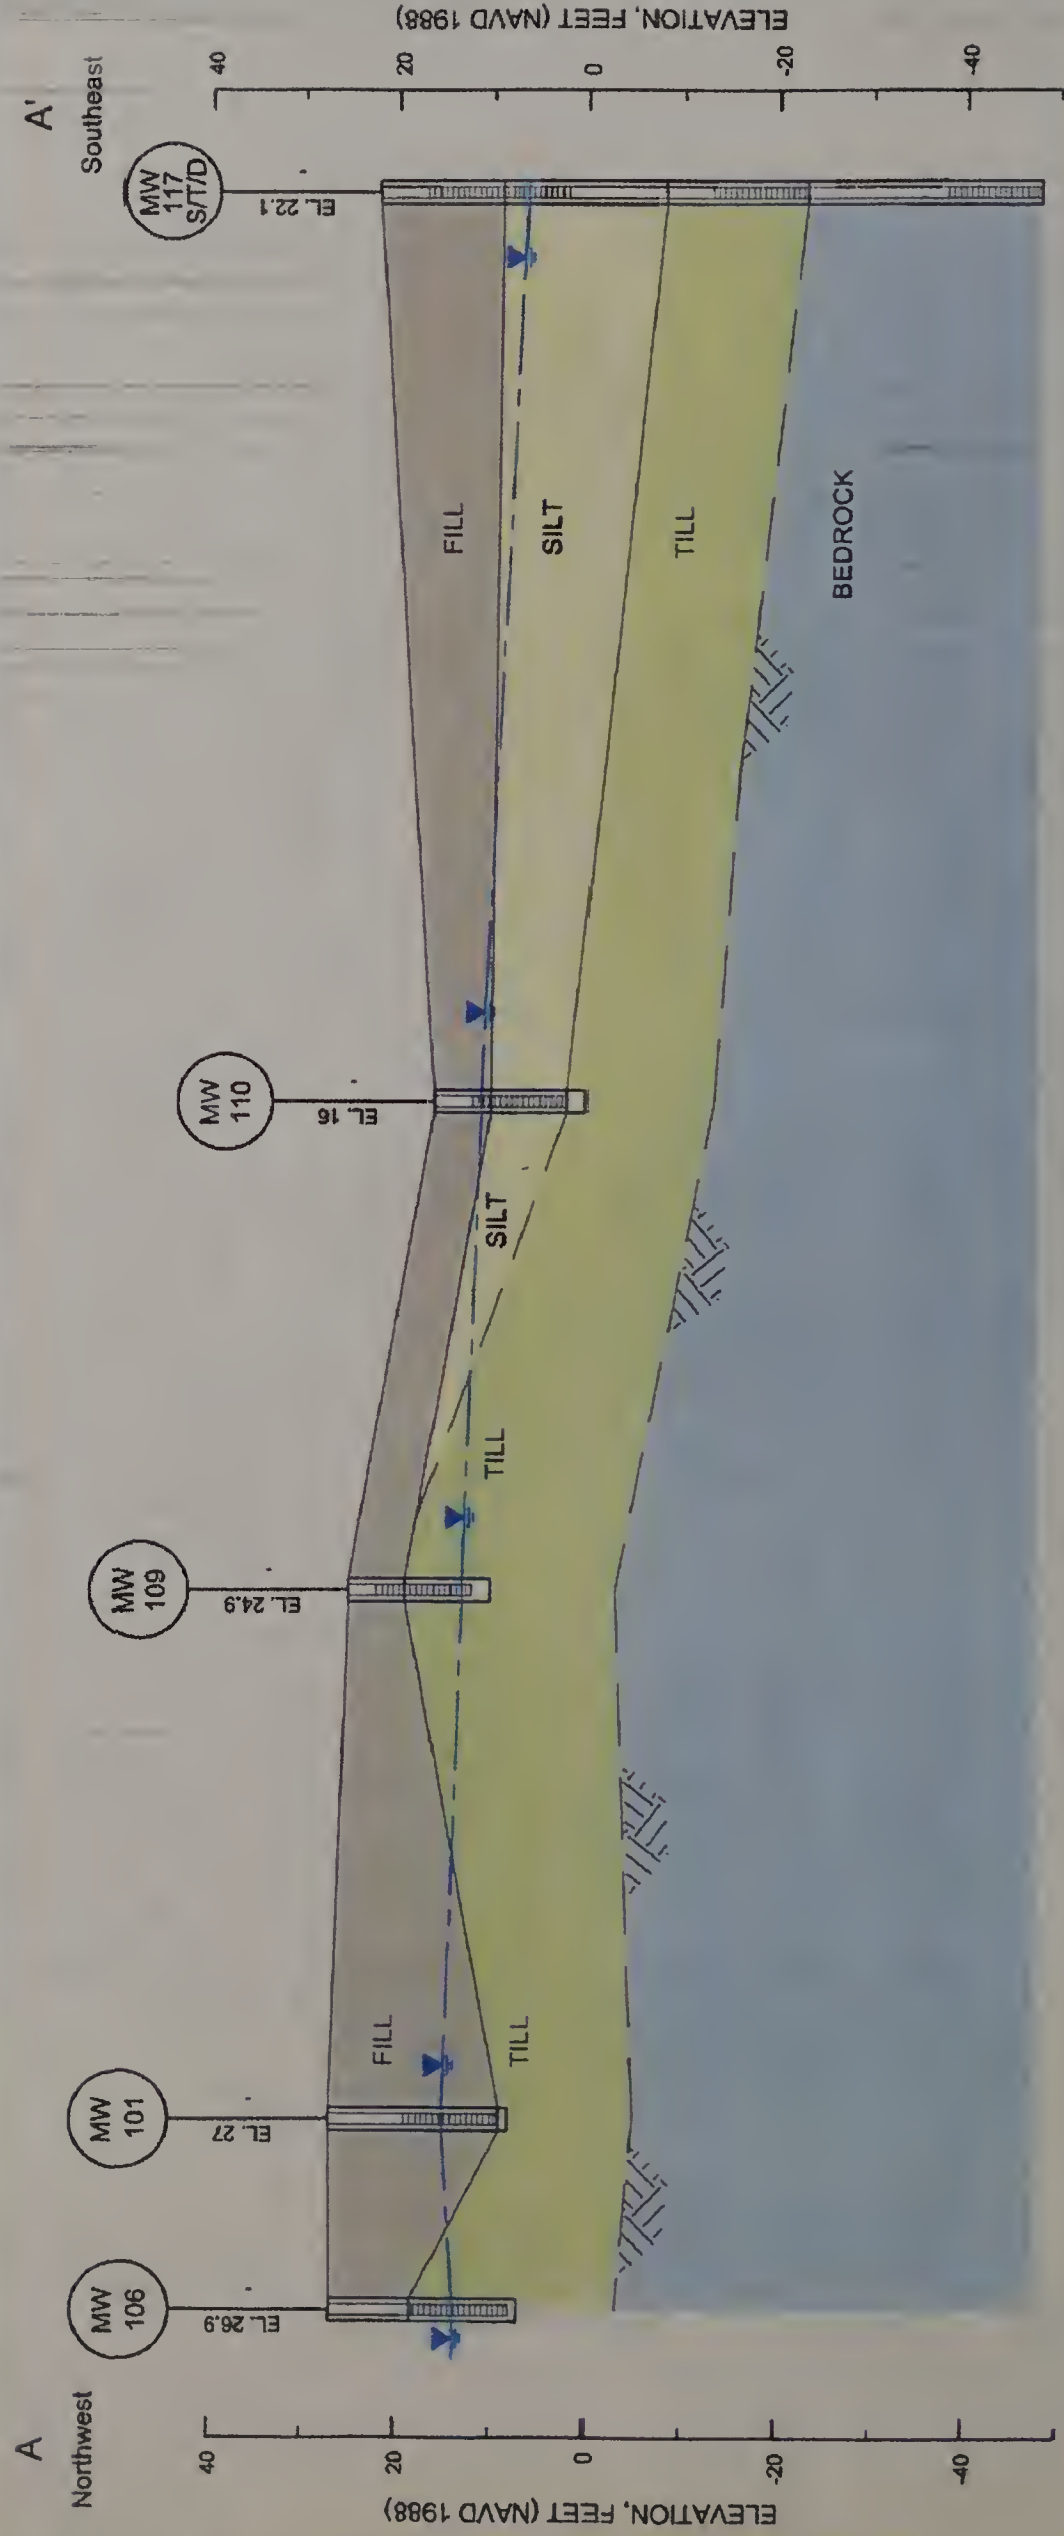
# Cross-Section

- Site is thoroughly characterized
- Nature, concentrations, and distribution of contaminants in subsurface have been determined
- Groundwater contamination has been mapped and is in a “steady state”

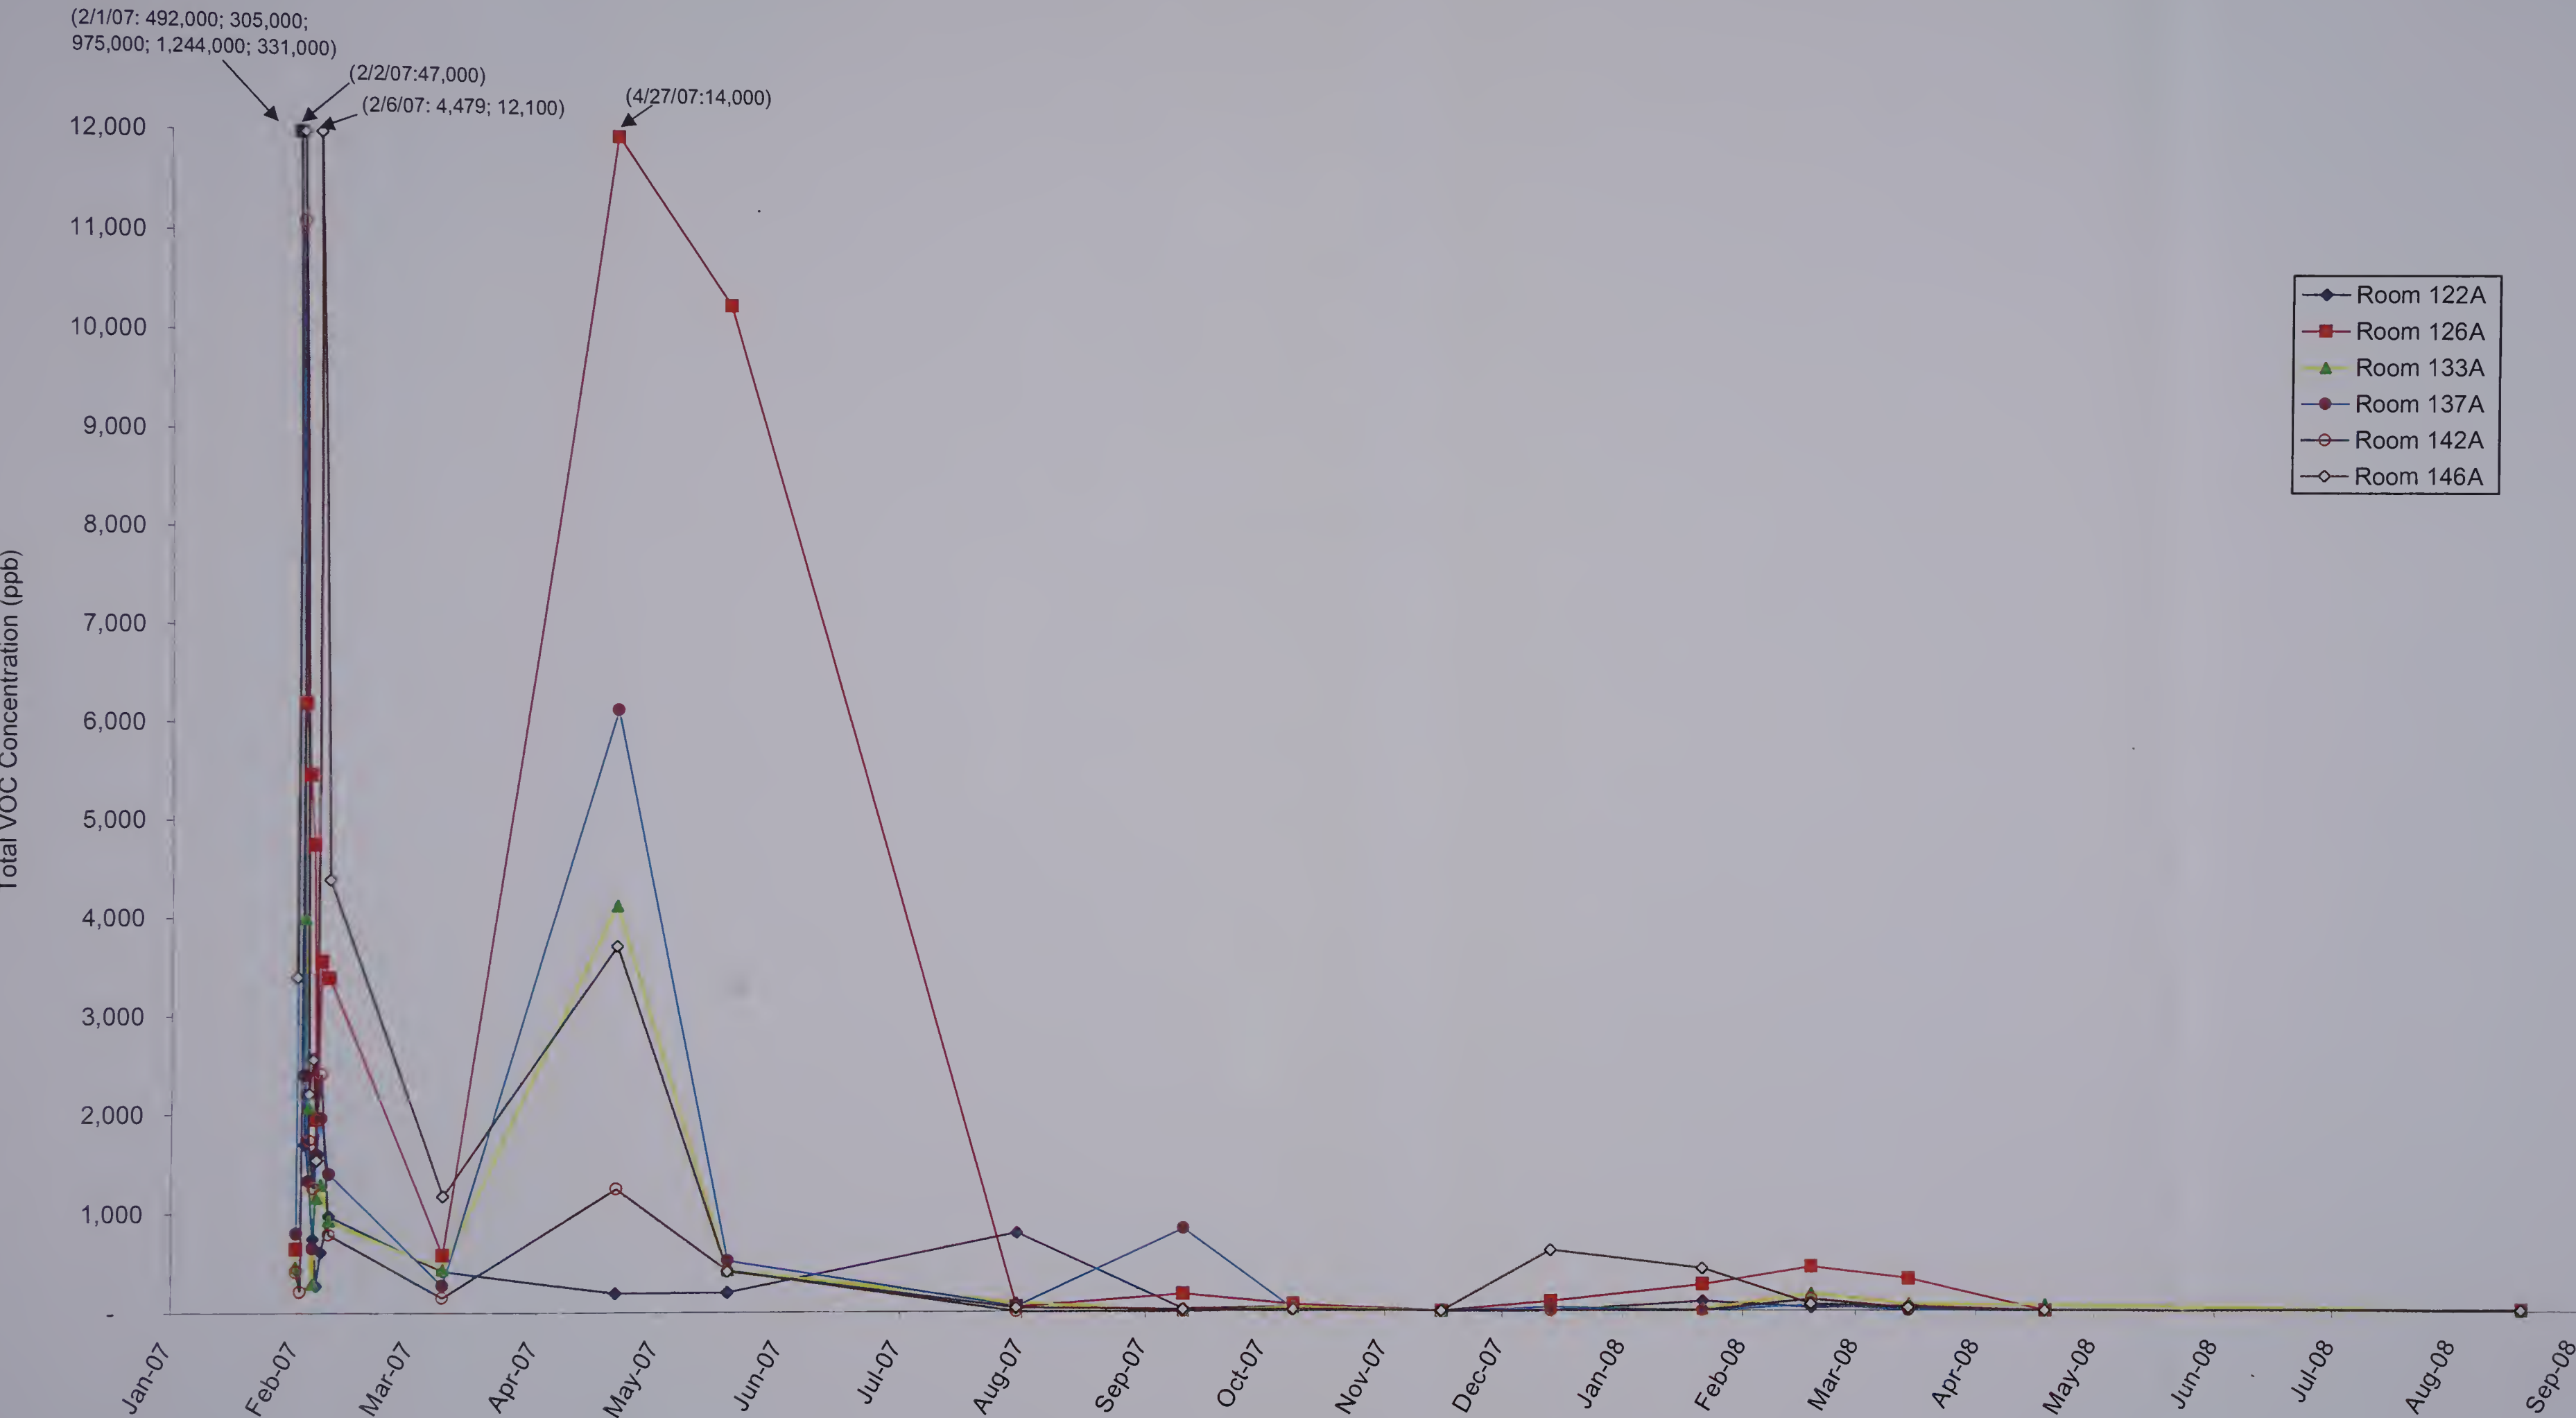
Graph 1  
Sub-Slab PID Monitoring Data: January 31, 2007 - September 30, 2008  
Total VOC Concentrations by PID at Sub-Slab Points in Selected Classrooms  
Capuano Center  
Somerville, Massachusetts

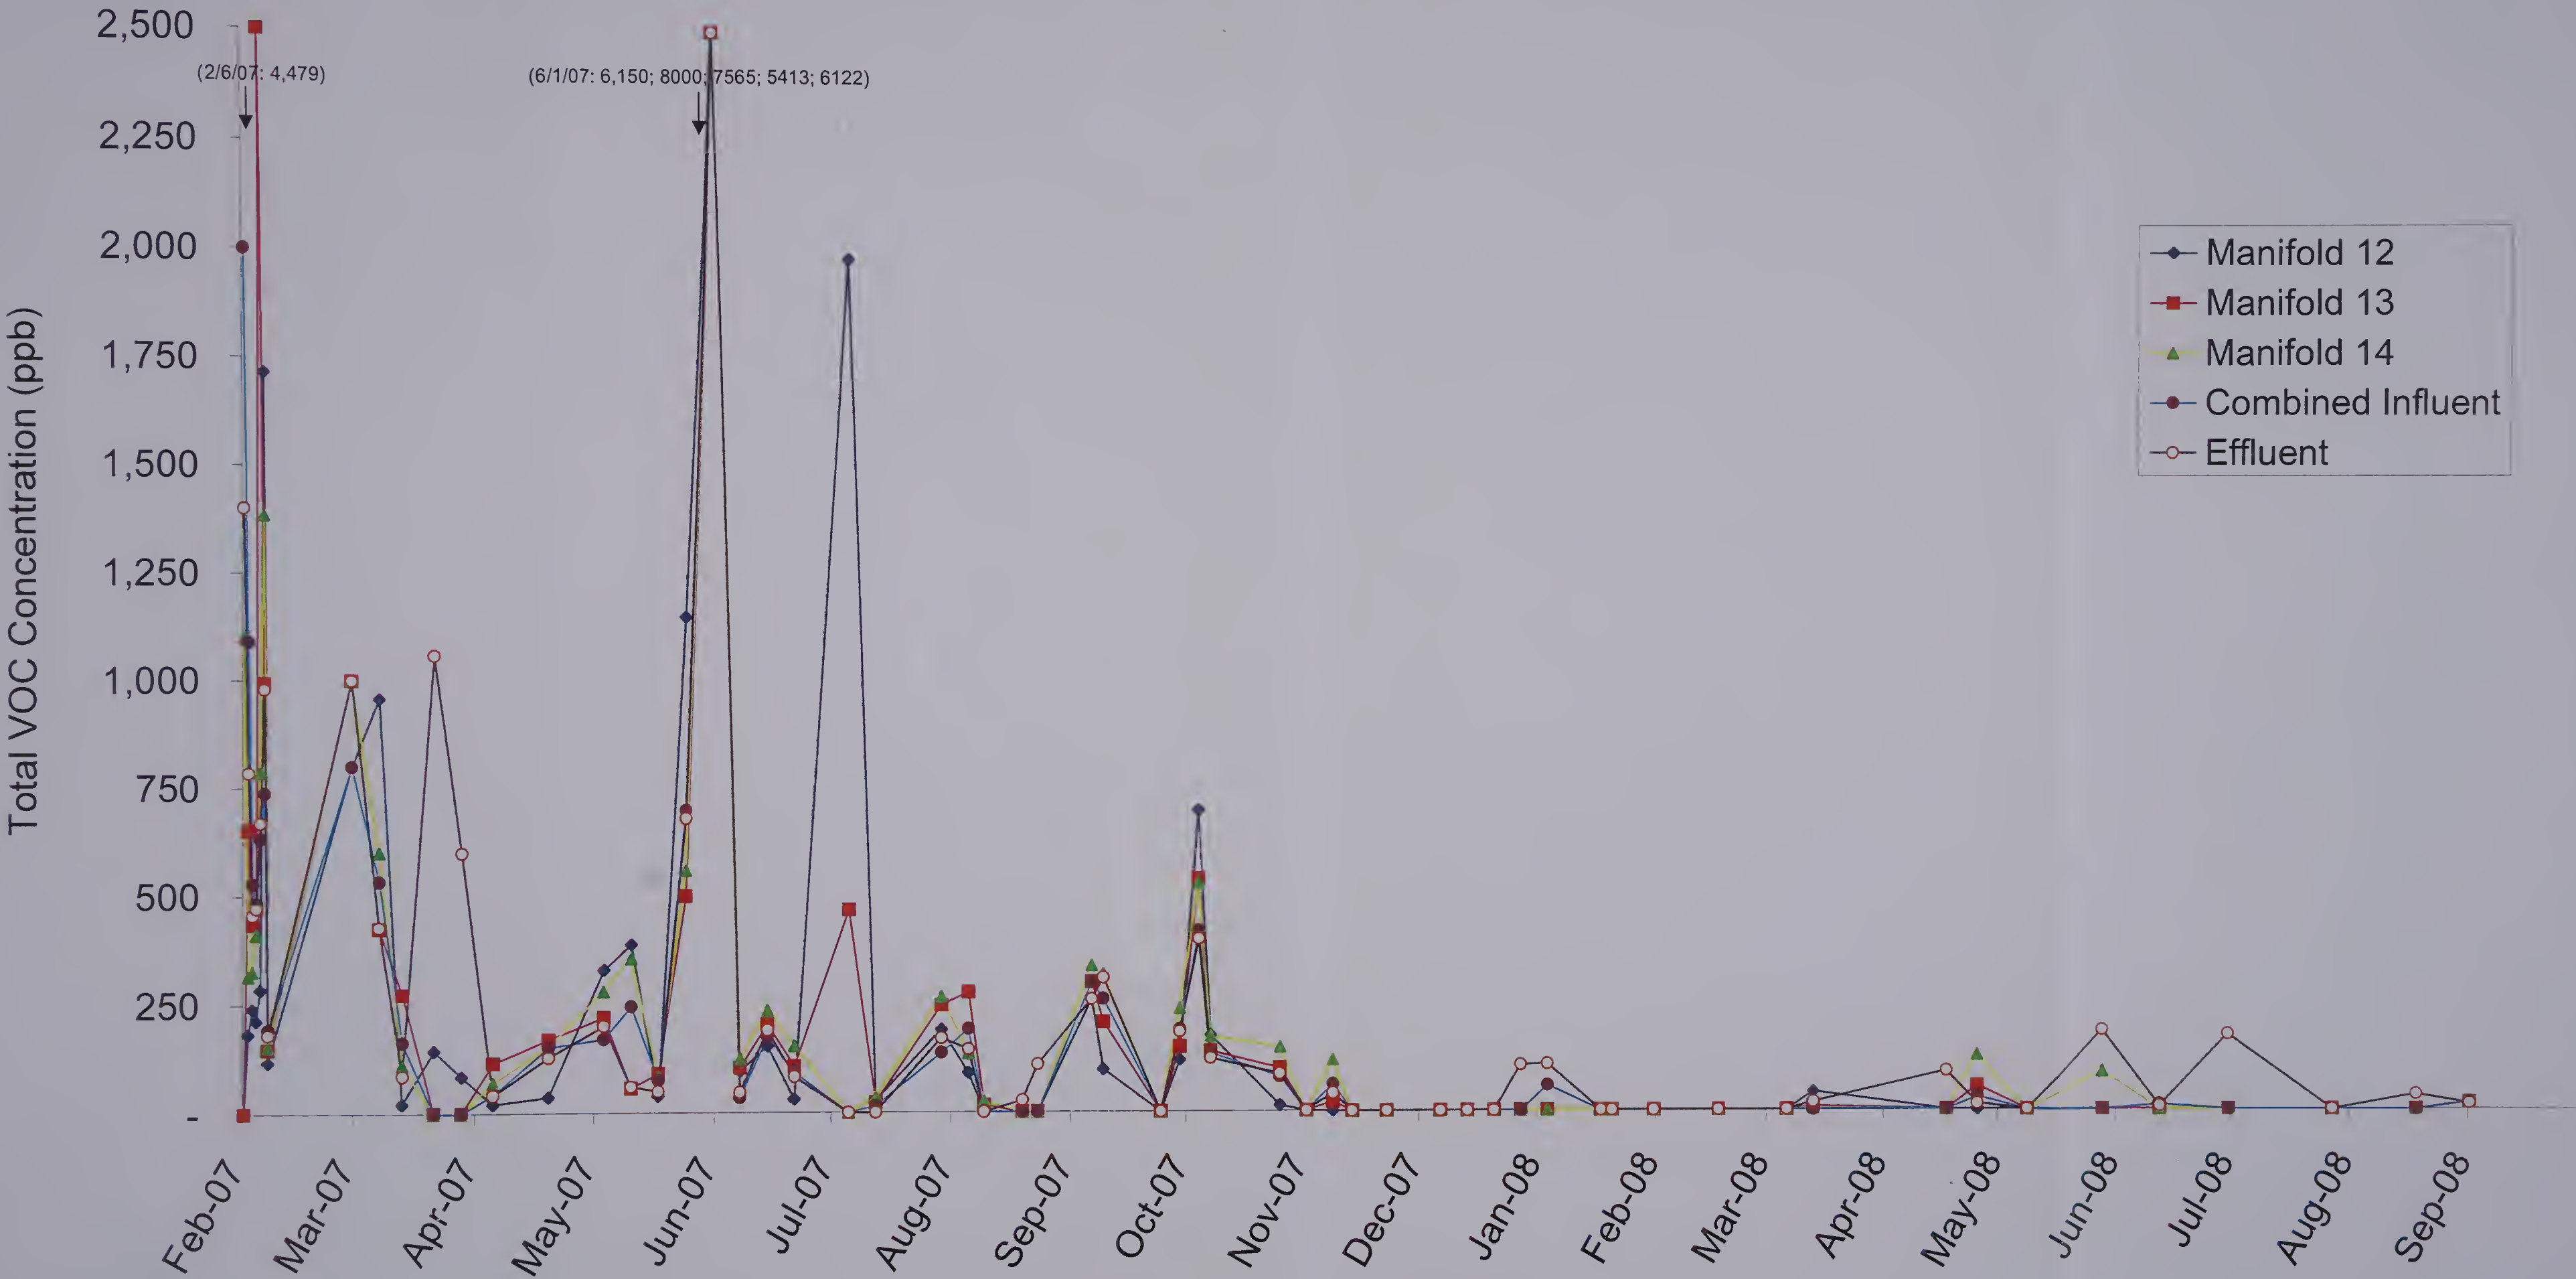
Graph 2  
Sub-Slab PID Monitoring Data: February 1, 2007 - September 30, 2008  
Total VOC Concentrations by PID at Blower Enclosure Monitoring Points  
Capuano Center  
Somerville, Massachusetts

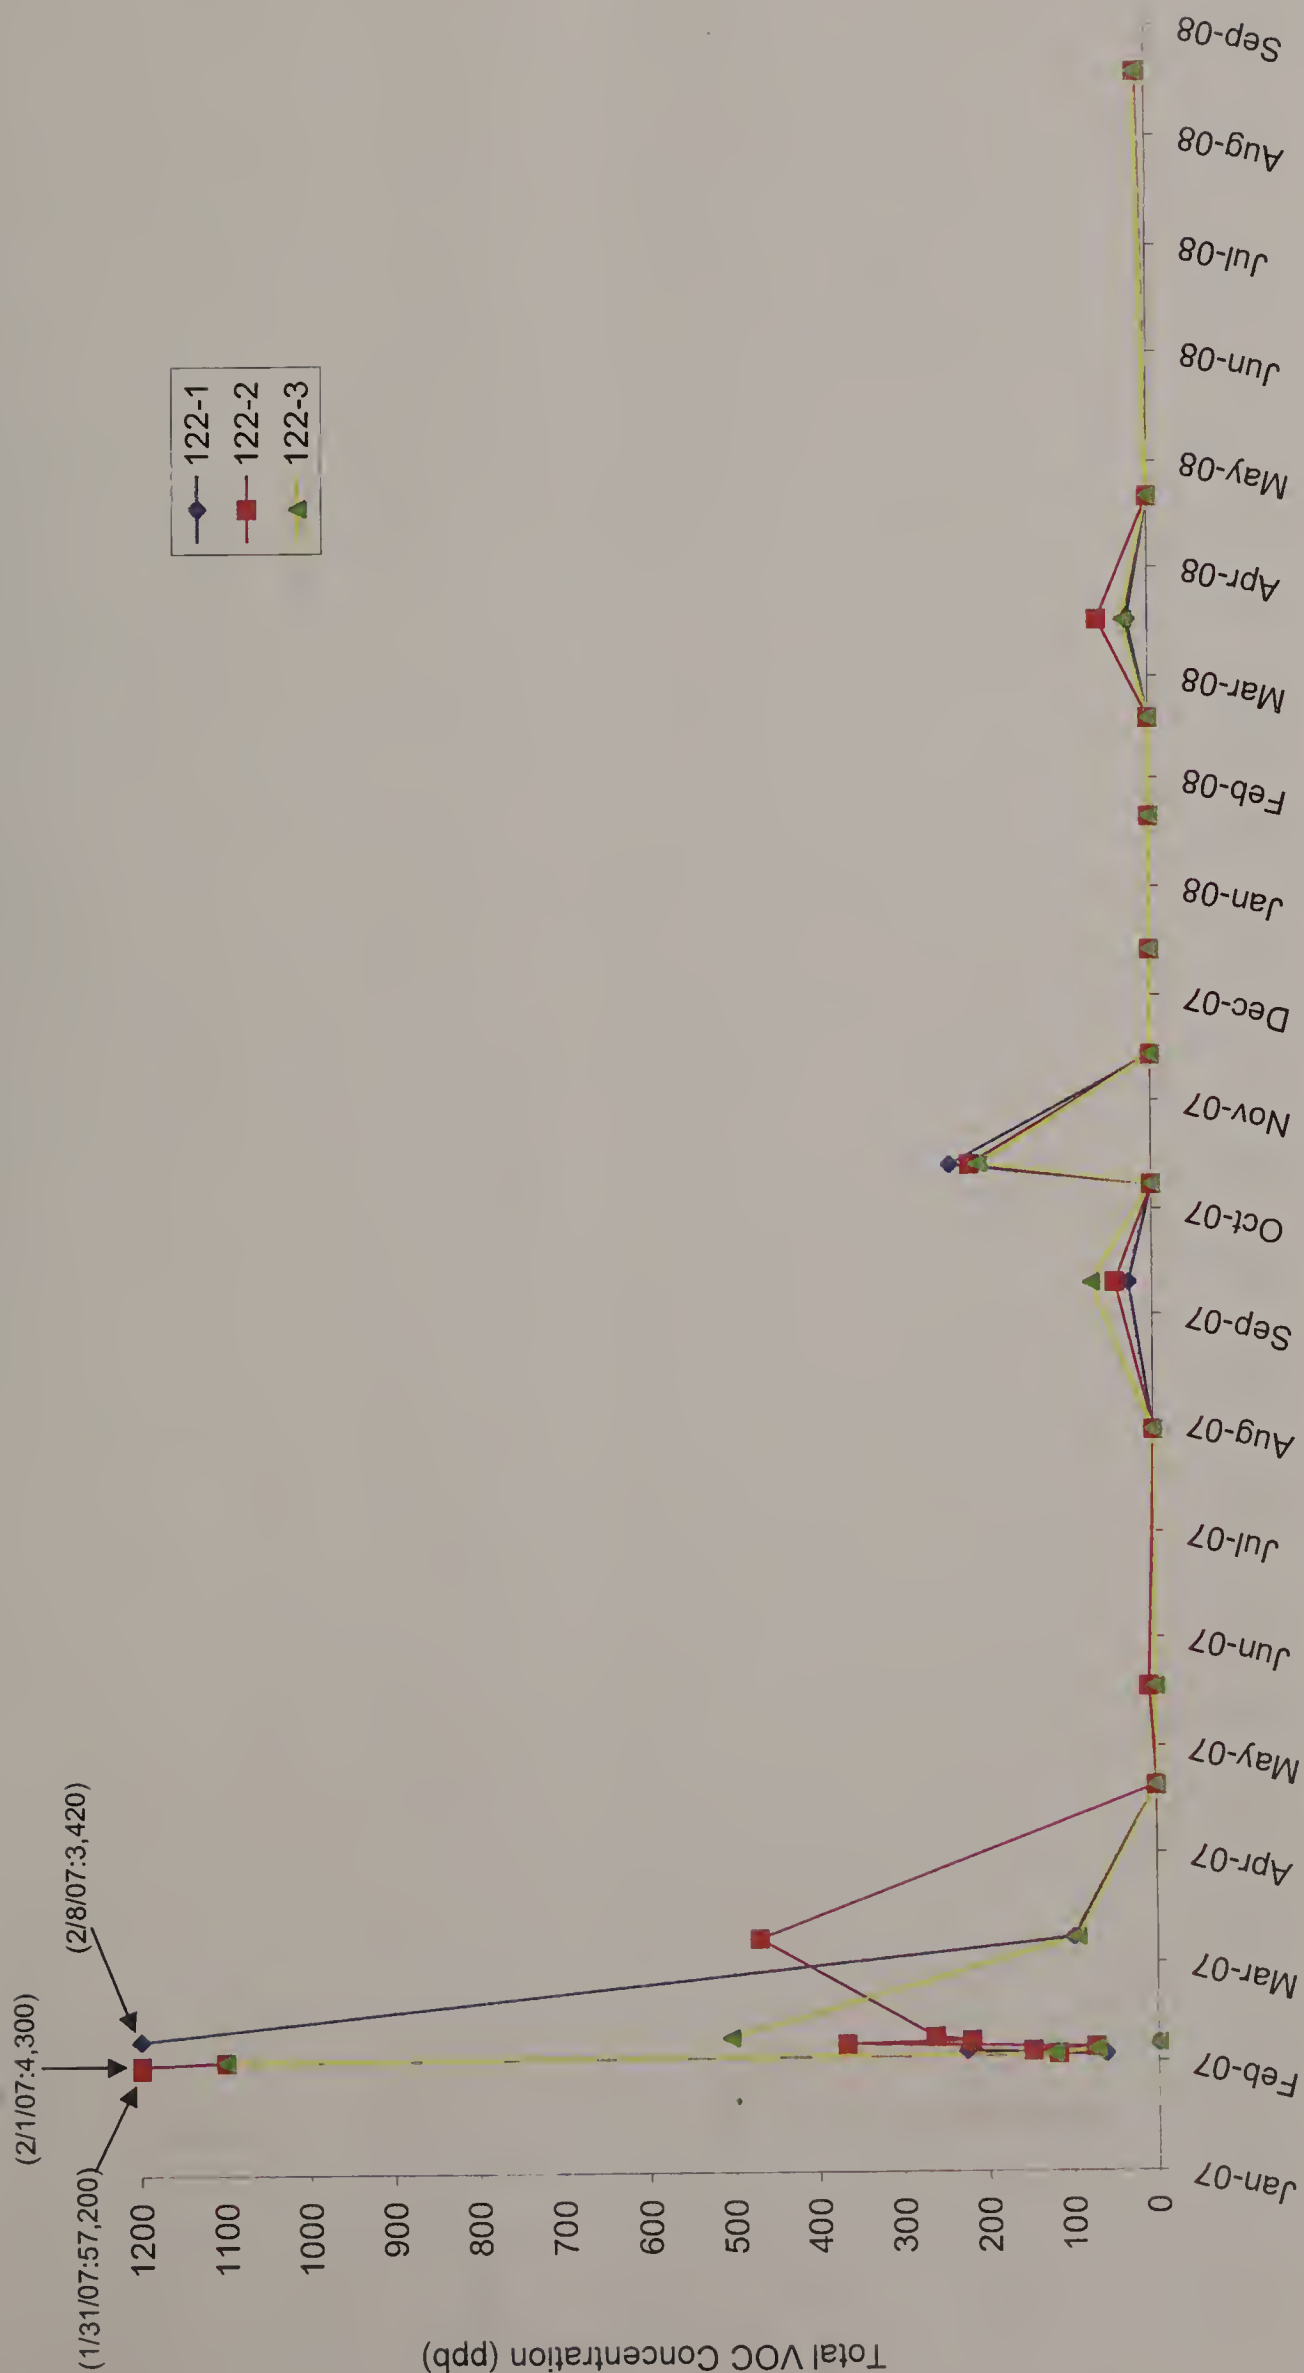
Graph 3

PID Monitoring Data: January 31, 2007 - September 30, 2008  
Total VOC Concentrations by PID at Exterior Monitoring Points - Room 122  
Capuano Center  
Somerville, Massachusetts

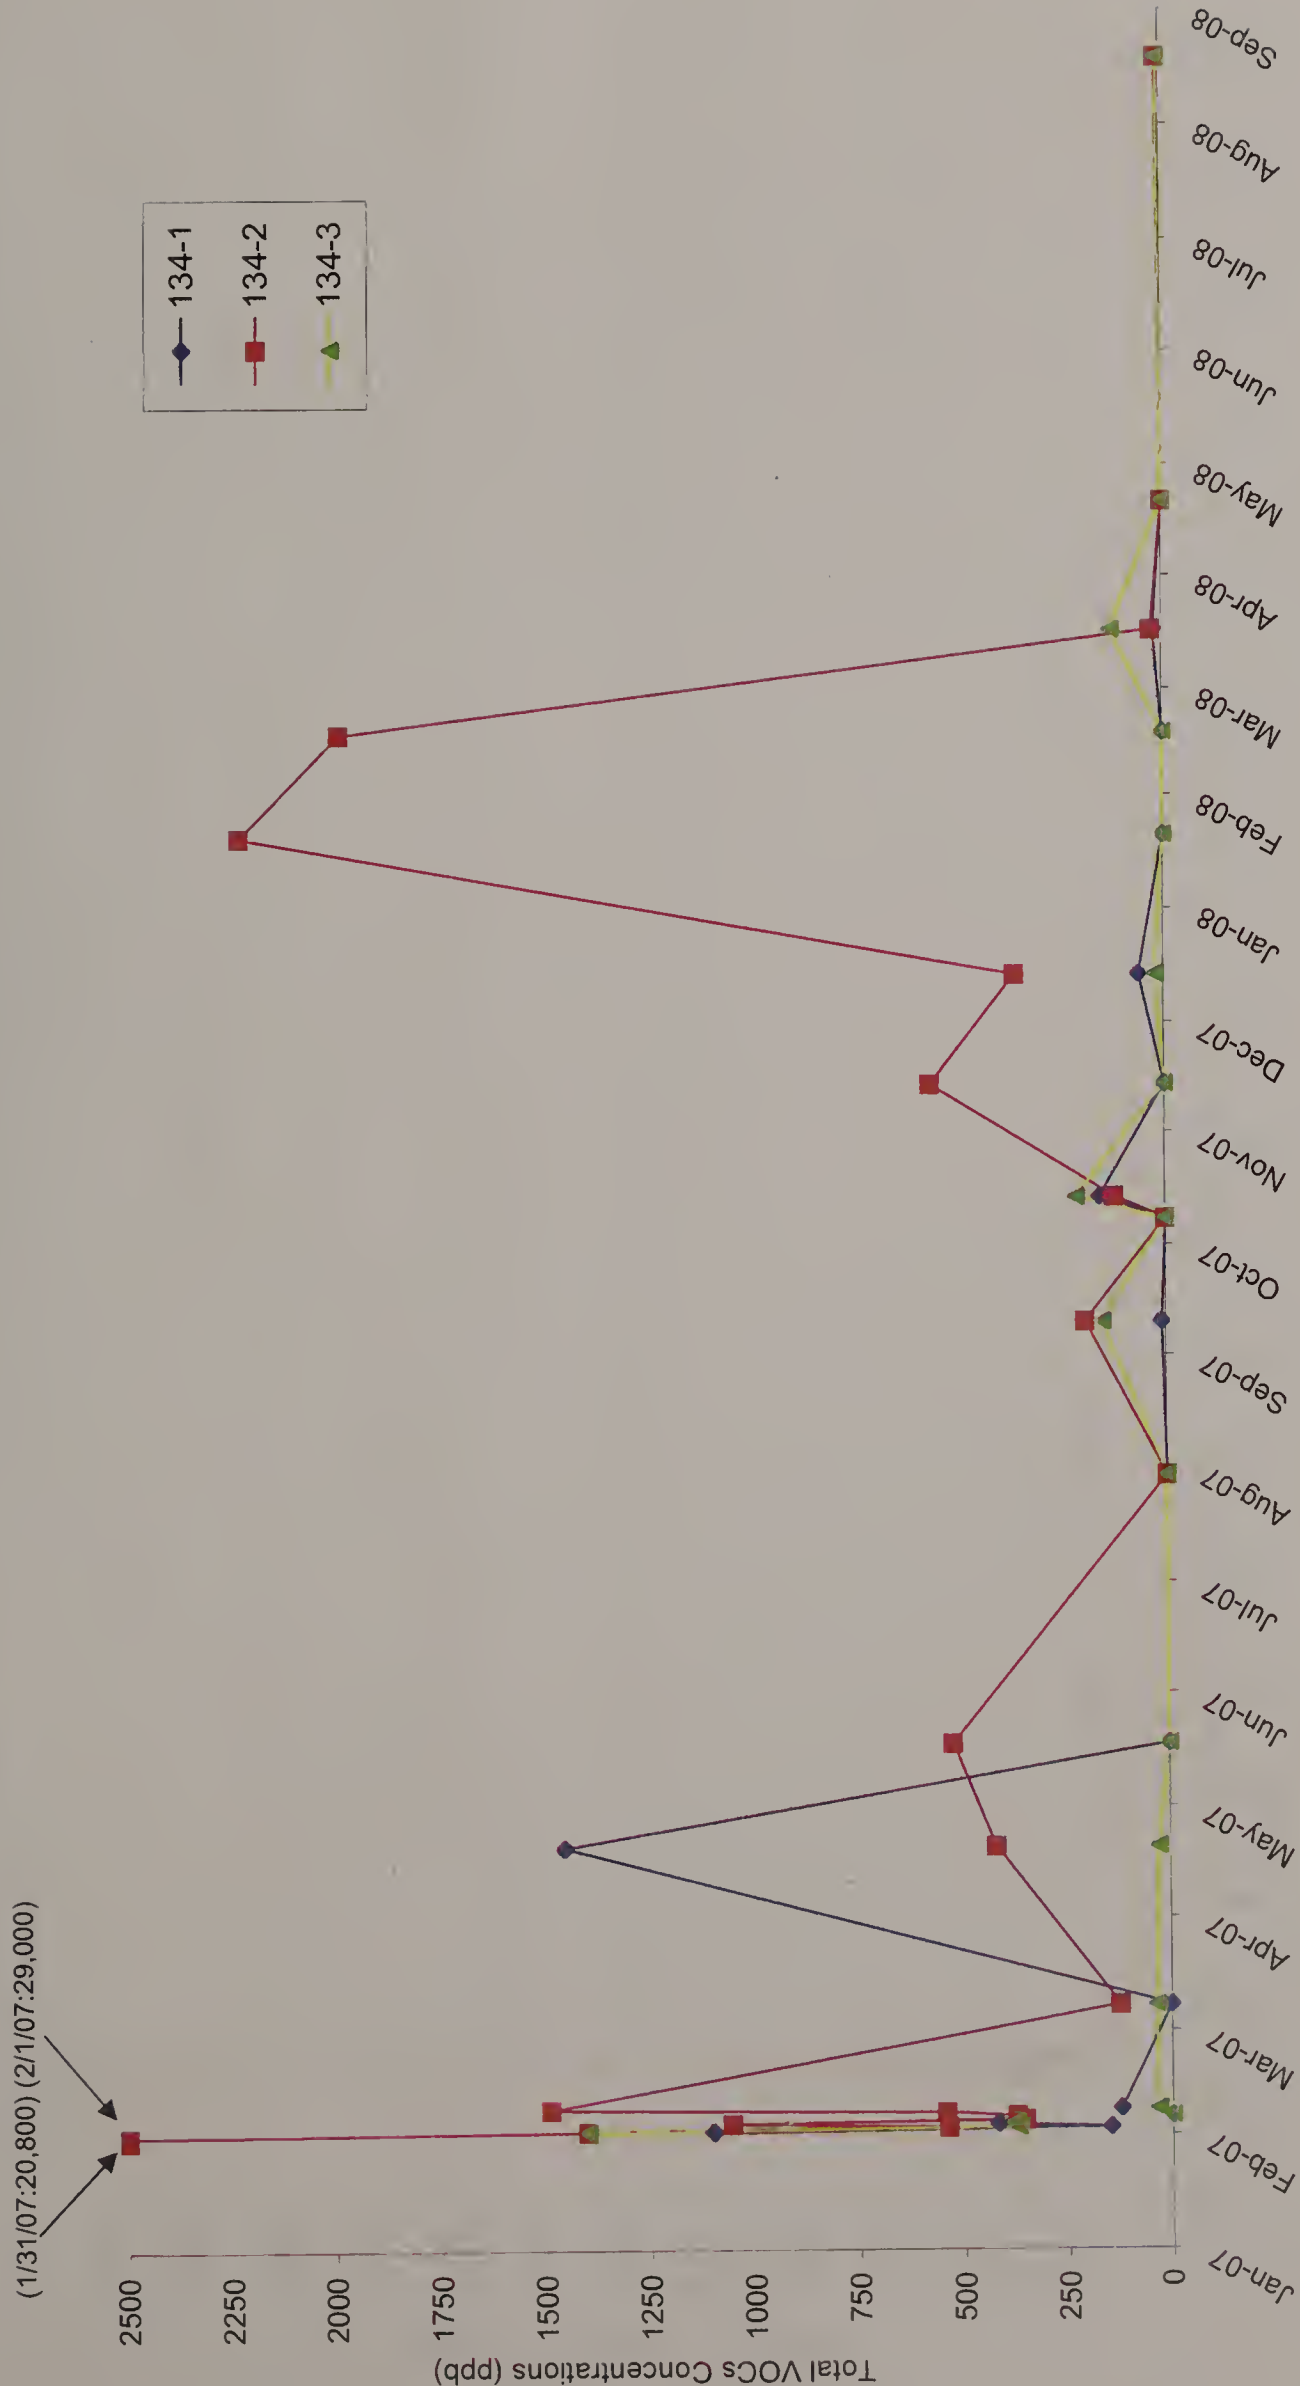
**Graph 5**  
**PID Monitoring Data: January 31, 2007 - September 30, 2008**  
**Total VOC Concentrations by PID at Exterior Monitoring Points - Room 134**  
**Capuano Center**  
**Somerville, Massachusetts**

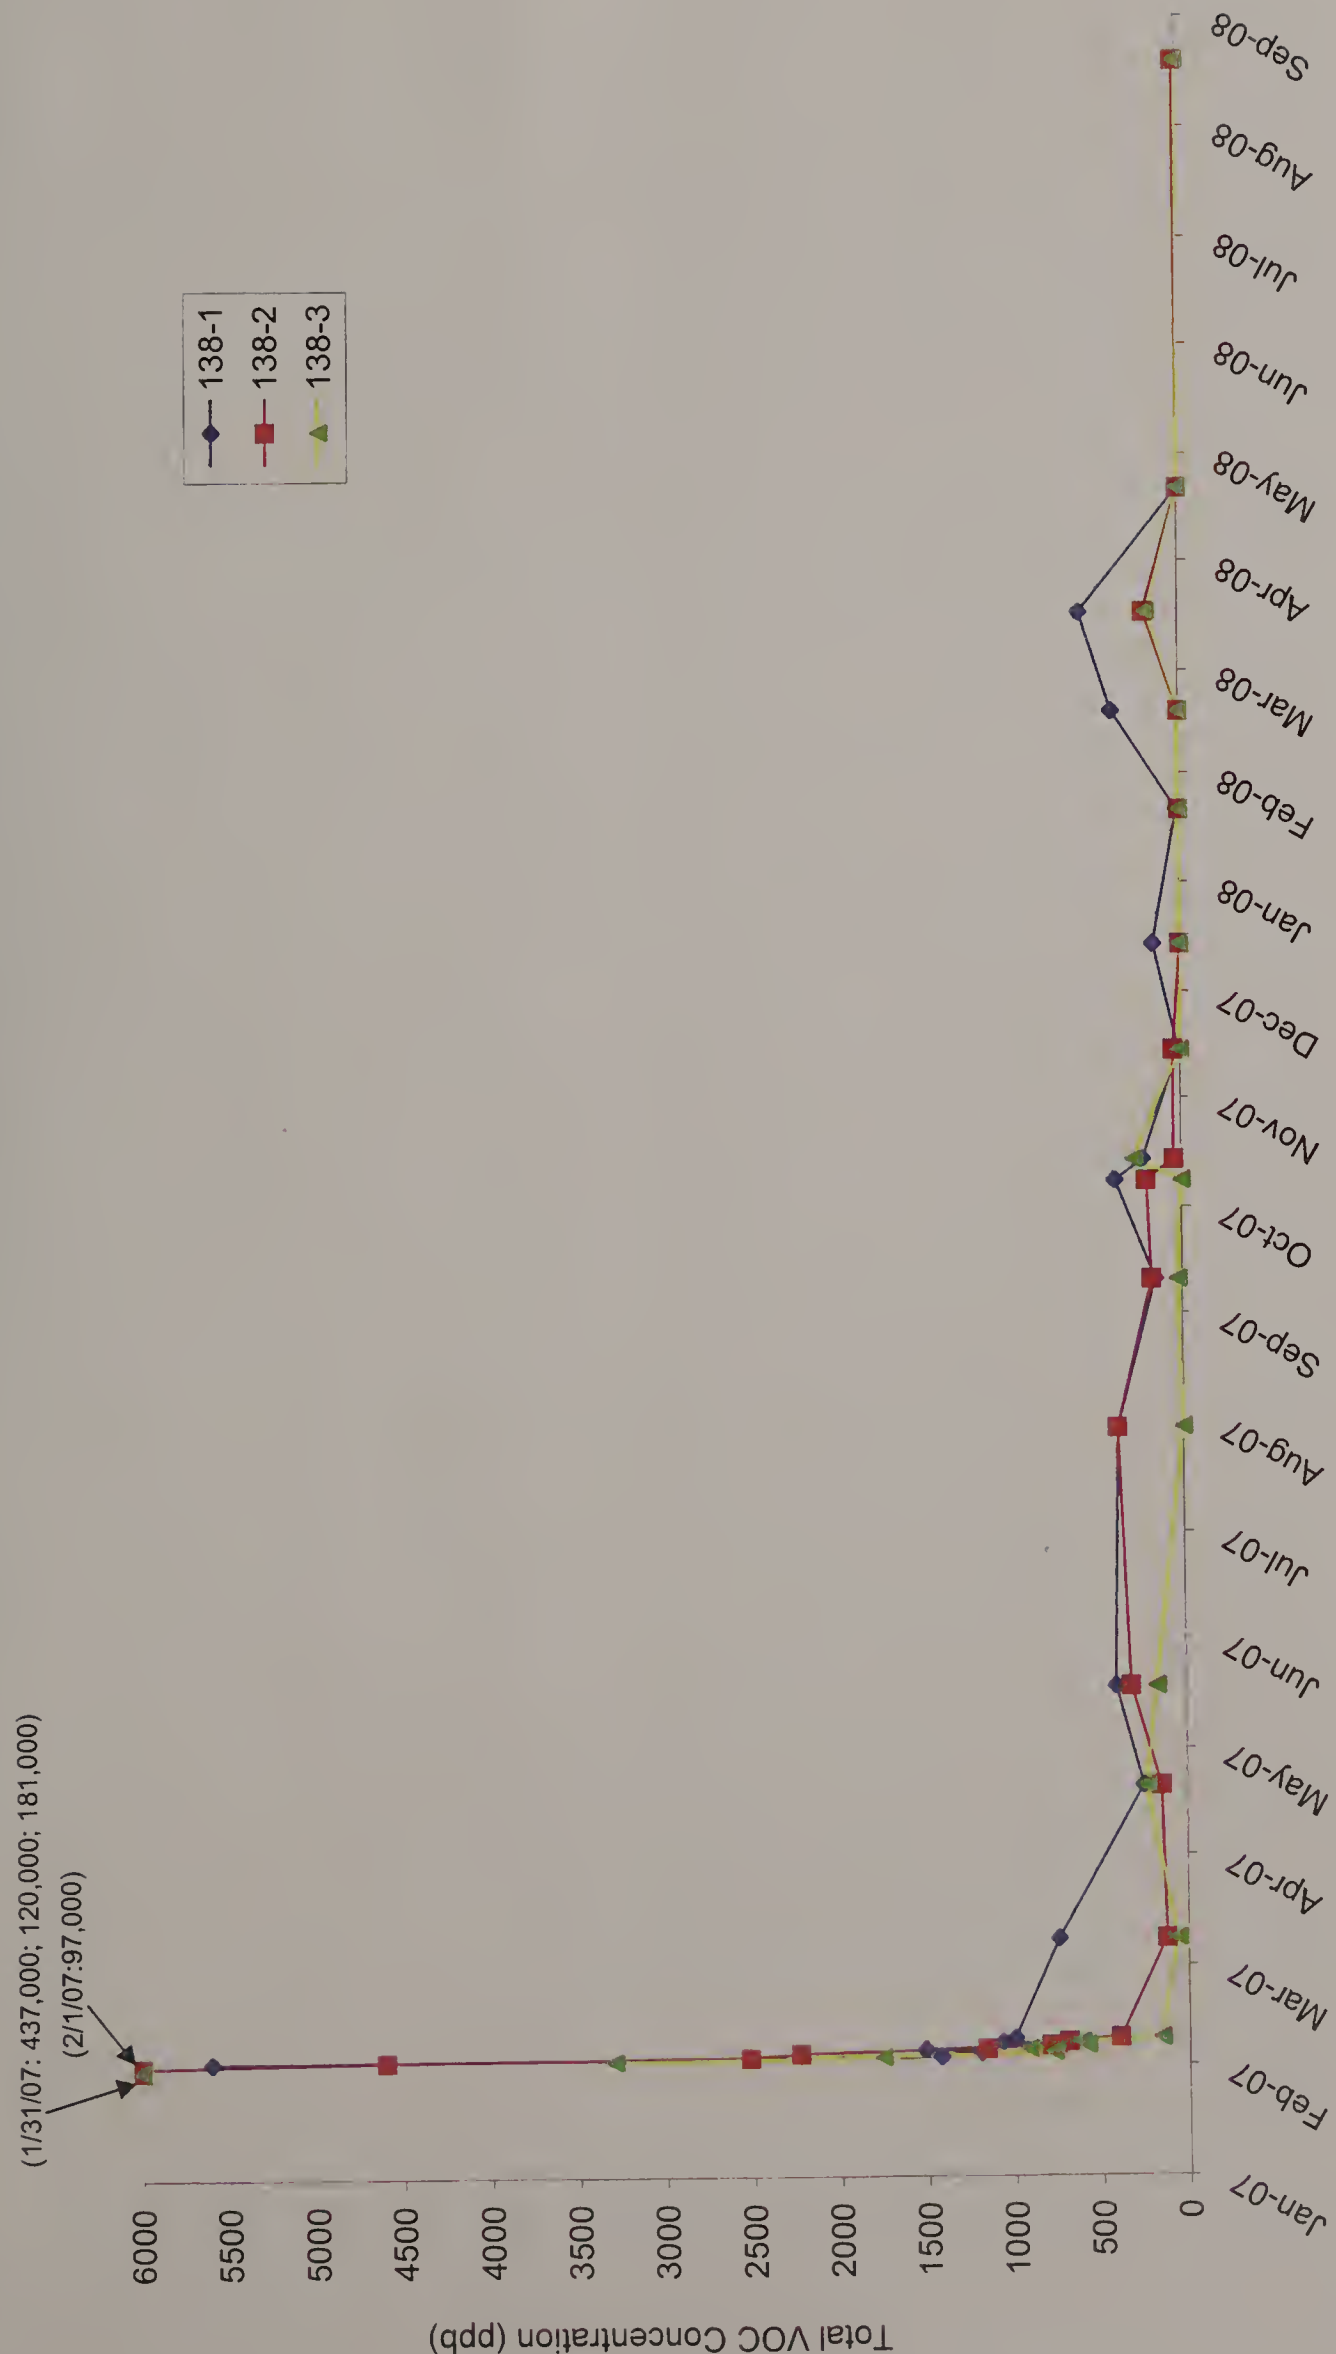
Graph 6  
 PID Monitoring Data: January 31, 2007 - September 30, 2008  
 Total VOC Concentrations by PID at Exterior Monitoring Points - Room 138  
 Capuano Center  
 Somerville, Massachusetts
